OHIO ENVIRONMENTAL PROTECTION AGENCY (Ohio EPA)

TARGET BROWNFIELD ASSESSMENT INVESTIGATION REPORT

**Mahoningside Project
Warren, Ohio
July 24-26, 2001 Sampling Investigation**

June 26, 2002

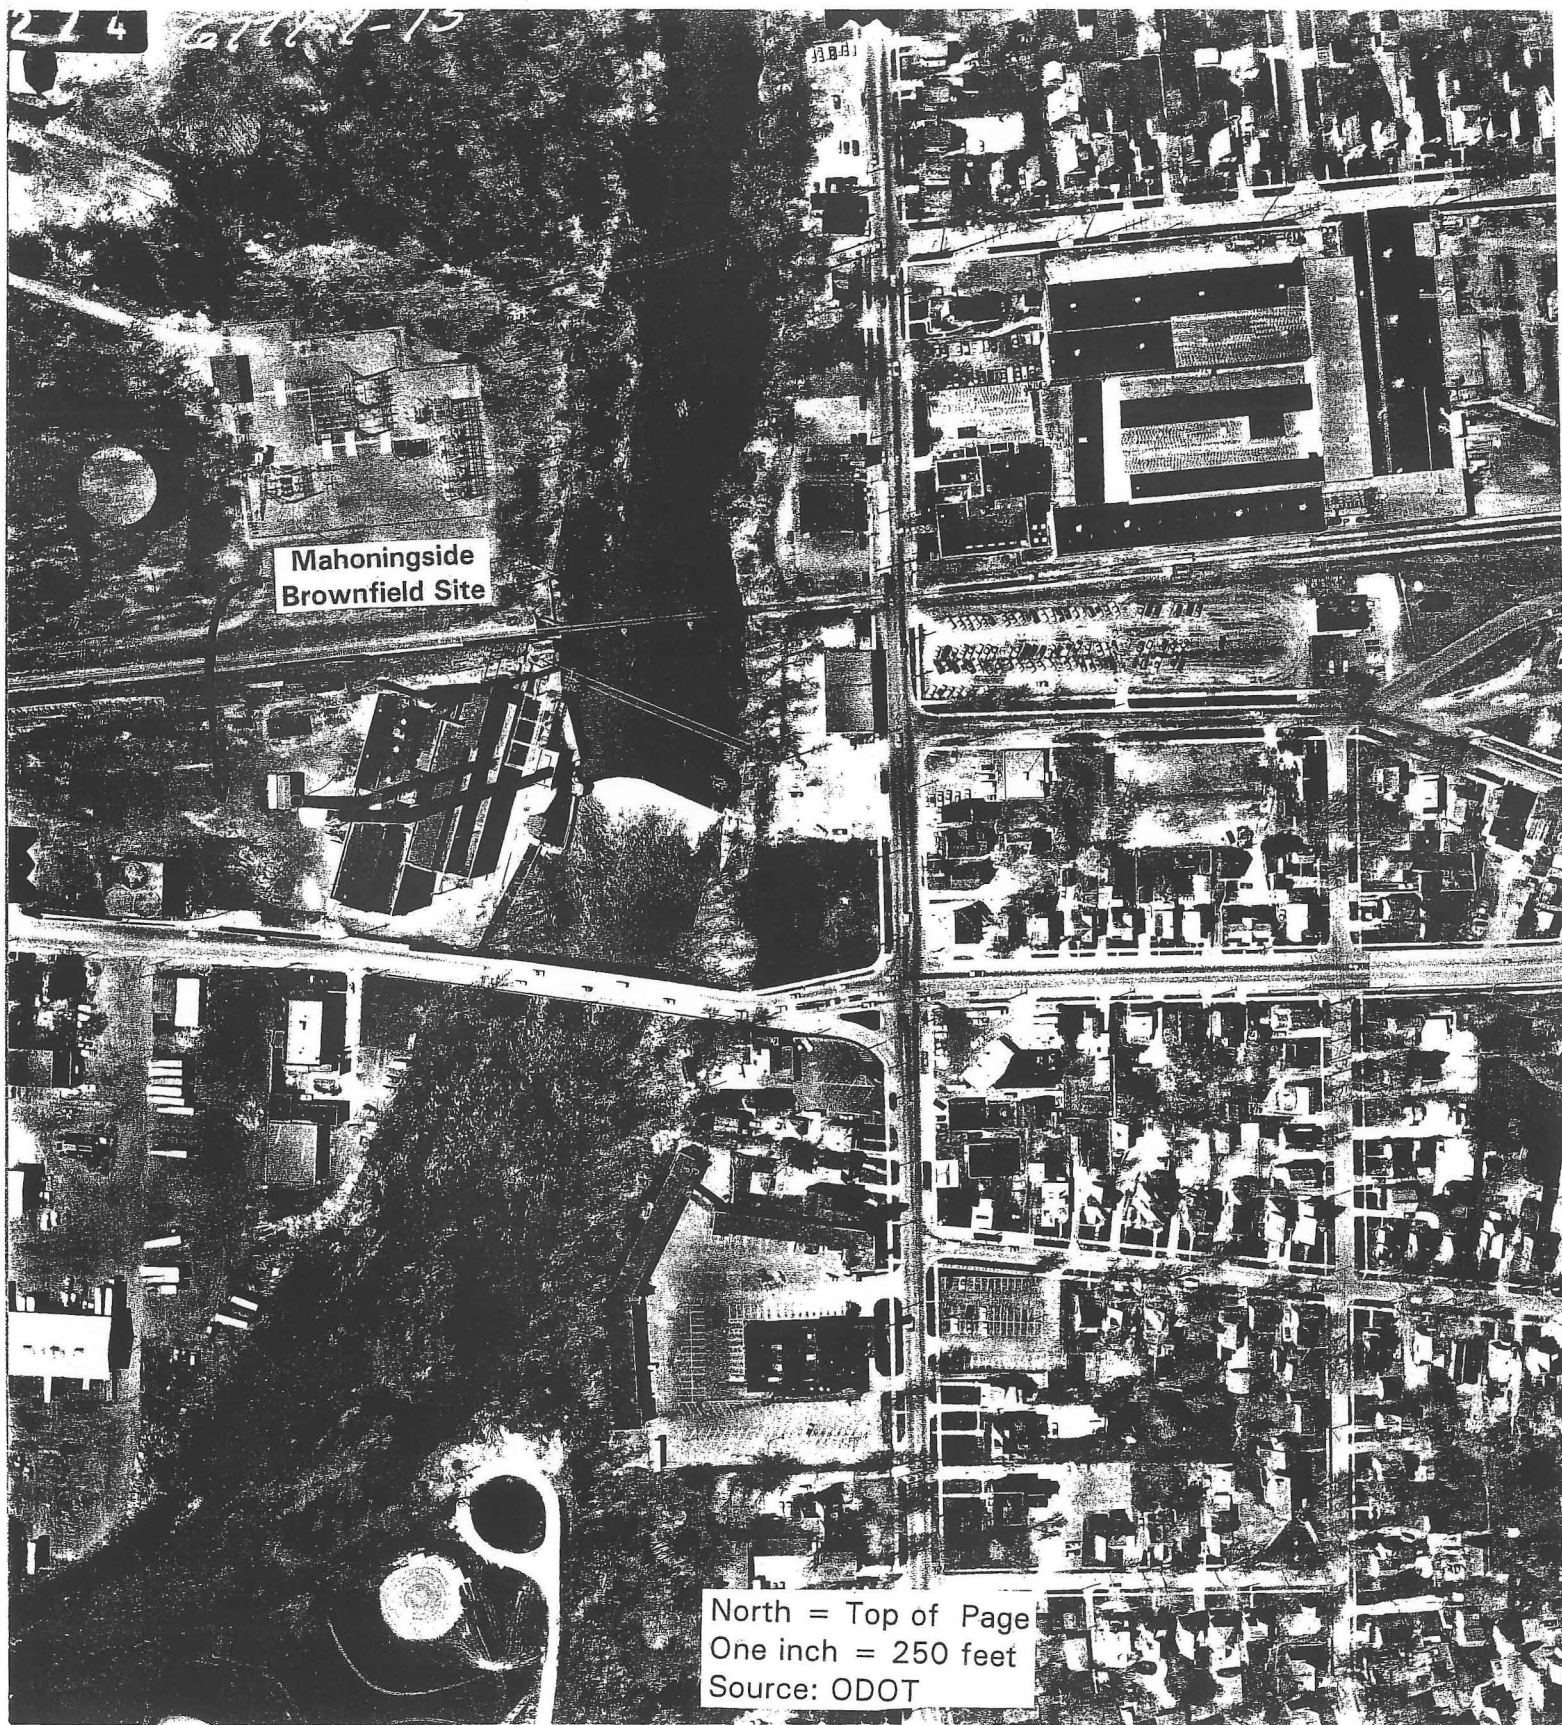
Figure 3: Mahoningside 1980 Air Photo

Mahoningside Site Location Map and in **Figure 2, Mahoningside Former Site Features Map**; and, see **Figure 3: Mahoningside 1980 Air Photo**. [Please note that the **Figure 3** 1980 air photo was used due to its large scale and its clarity. It shows most of the site and gives a general understanding of the site. More recent, large scale photography was not available. Only two small buildings remain, while the others have been raised and only foundations remain.] (ODOT, 1980 and USGS, 1984.)

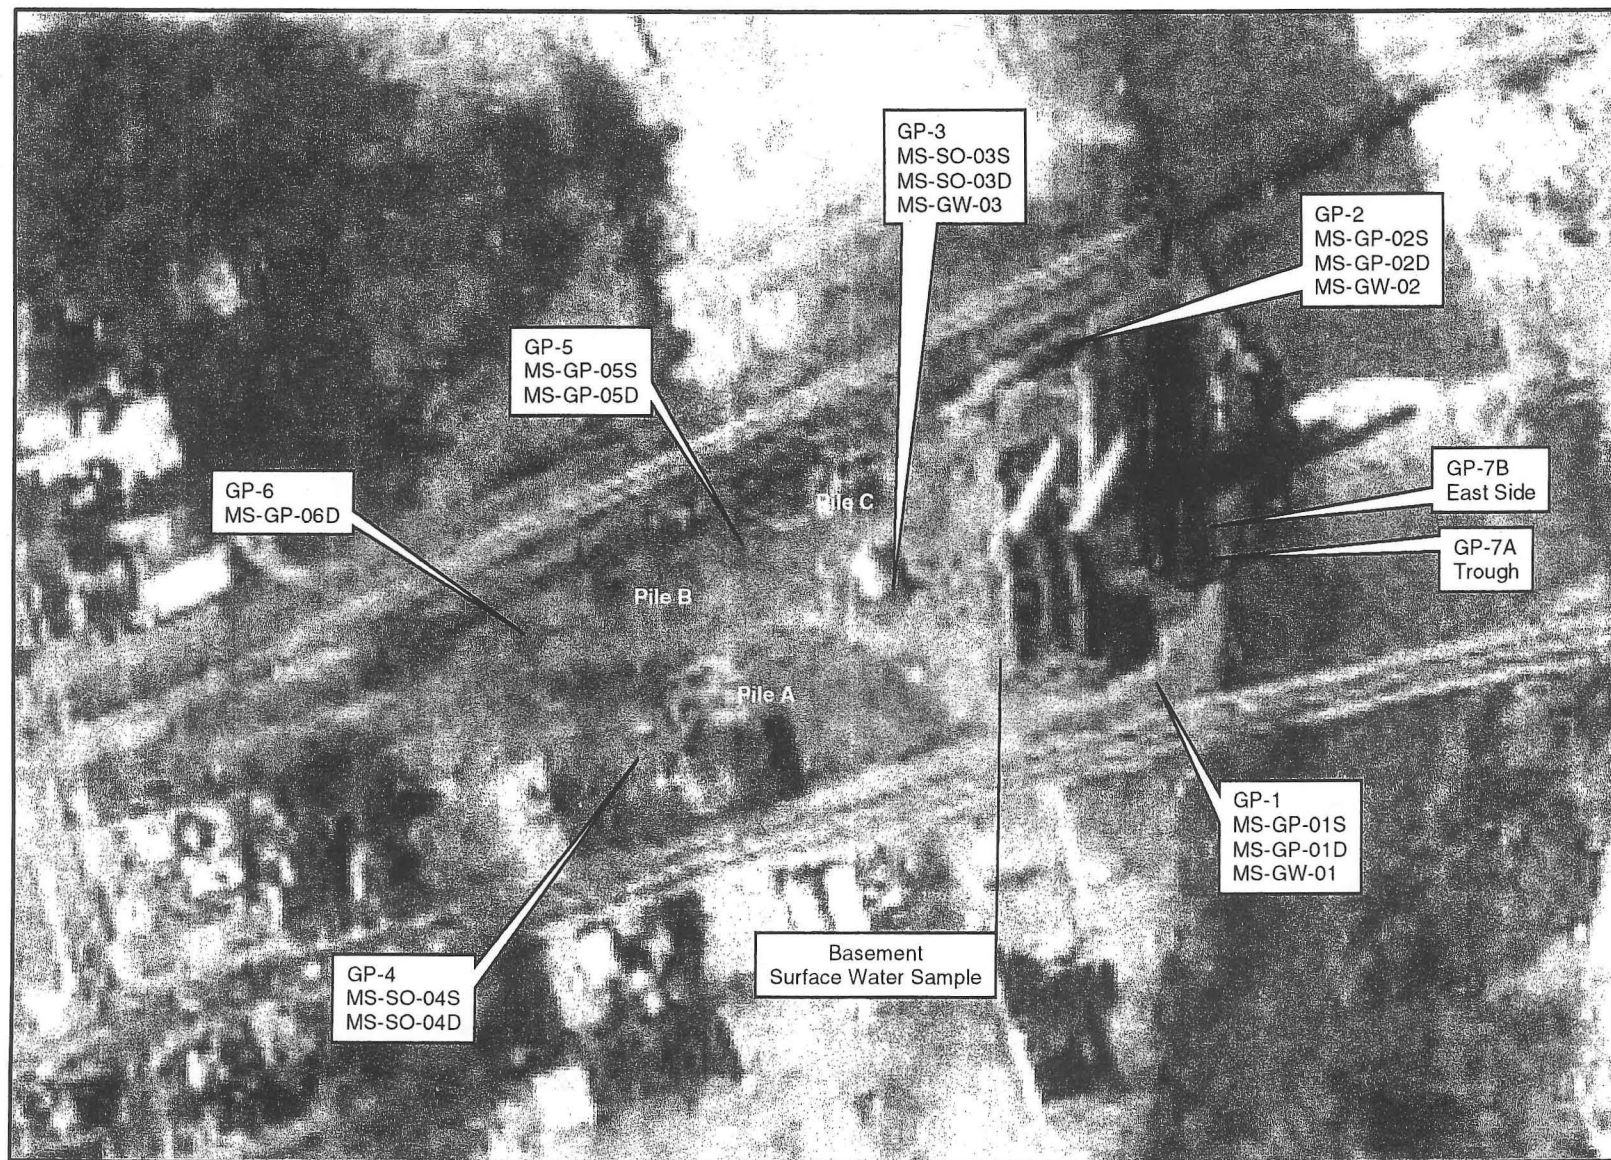
One surface water sample was collected and analyzed for this TBA investigation. (See **Figure 6** and **Table 4** for specific information.) This surface water sample was taken from the standing water in the basement of the power plant foundation. The analyses was necessary for the basement water to be accepted by the City of Warren

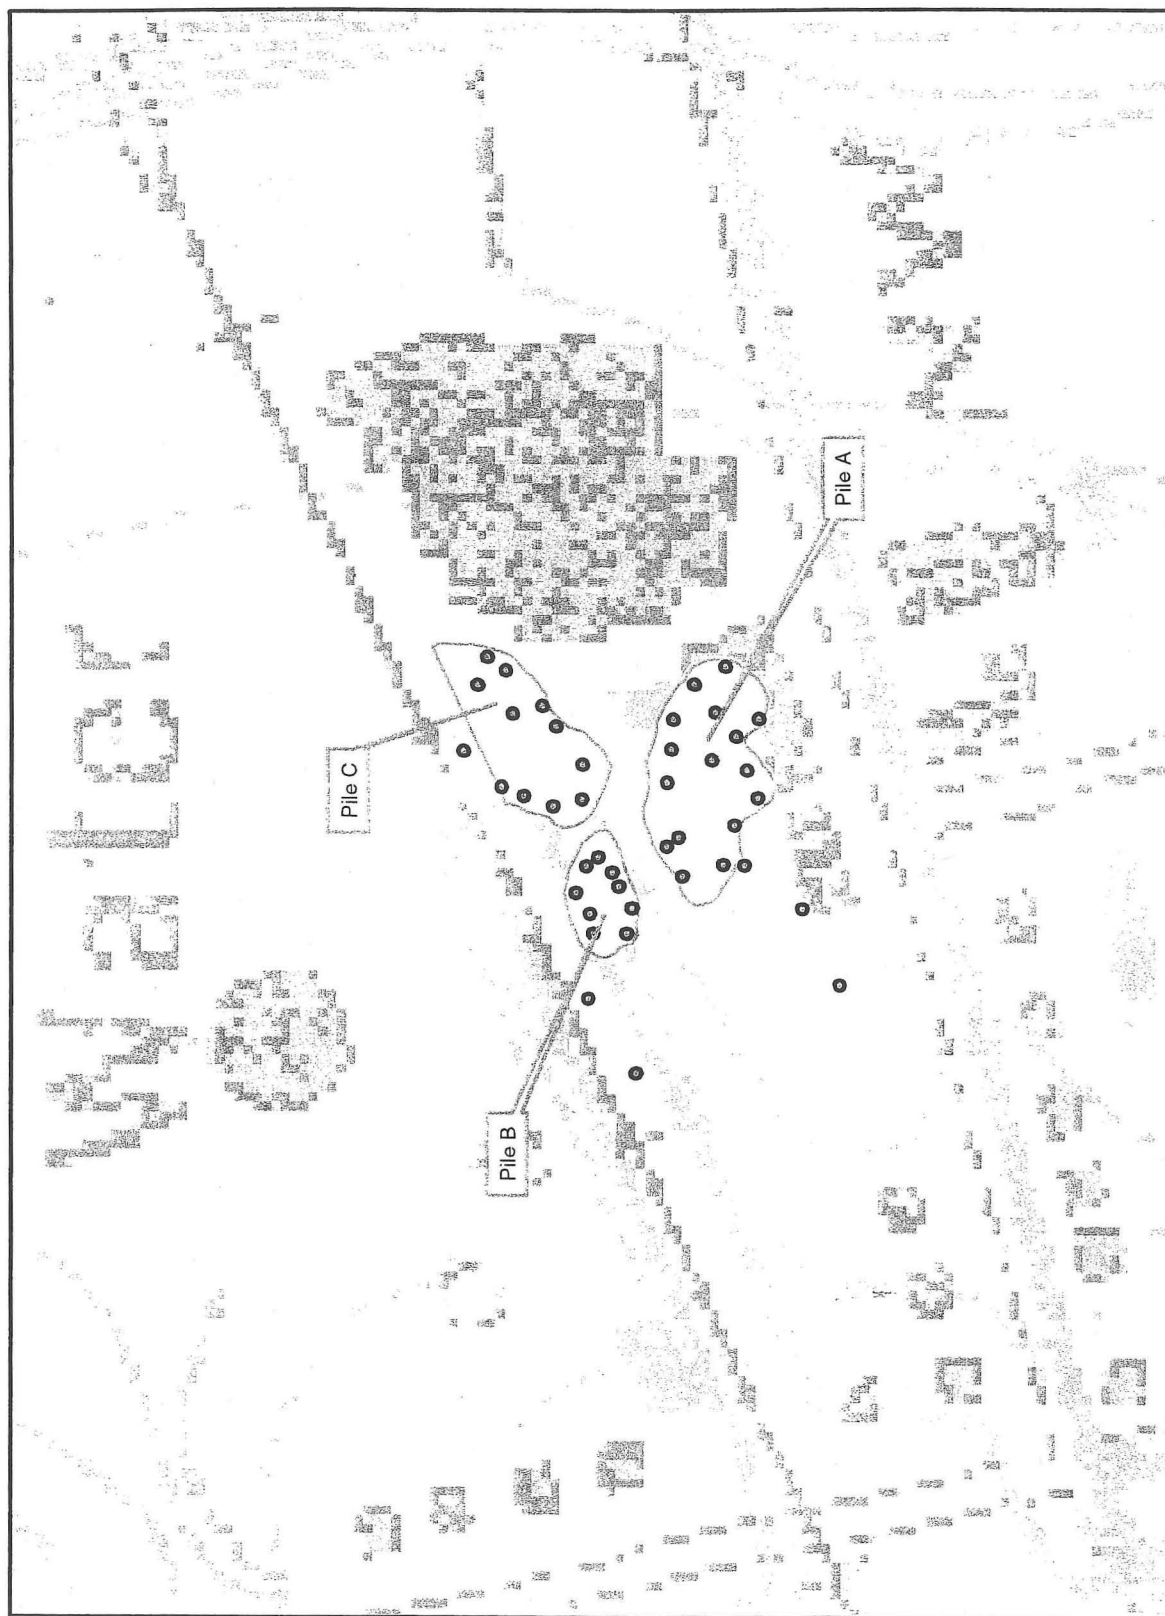
Figure 7: Mahoningside Piles A, B & C Map

The west side of the property is currently used as a temporary office and staging area. The three large waste piles are also located here from the former power plant building. The foundation basement are located on the river's edge at the east end of the facility. (U.S. EPA, 2001.)

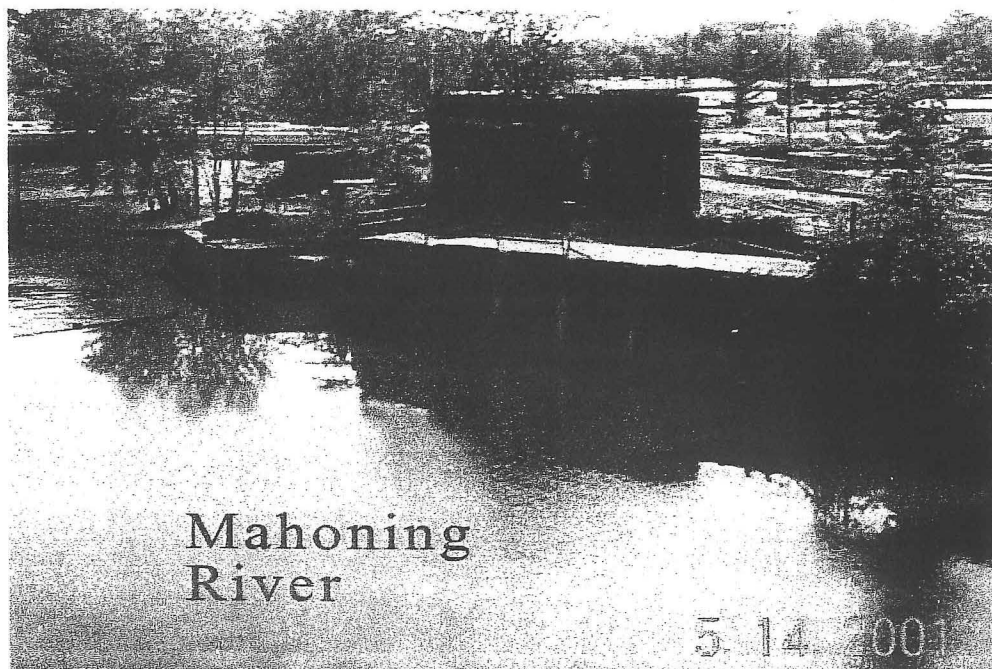
ABOVE PHOTO: Mahoningside site, May 14, 2001 Reconnaissance
View from East Side of the River, from Railroad Bridge; Looking SouthWest at Site

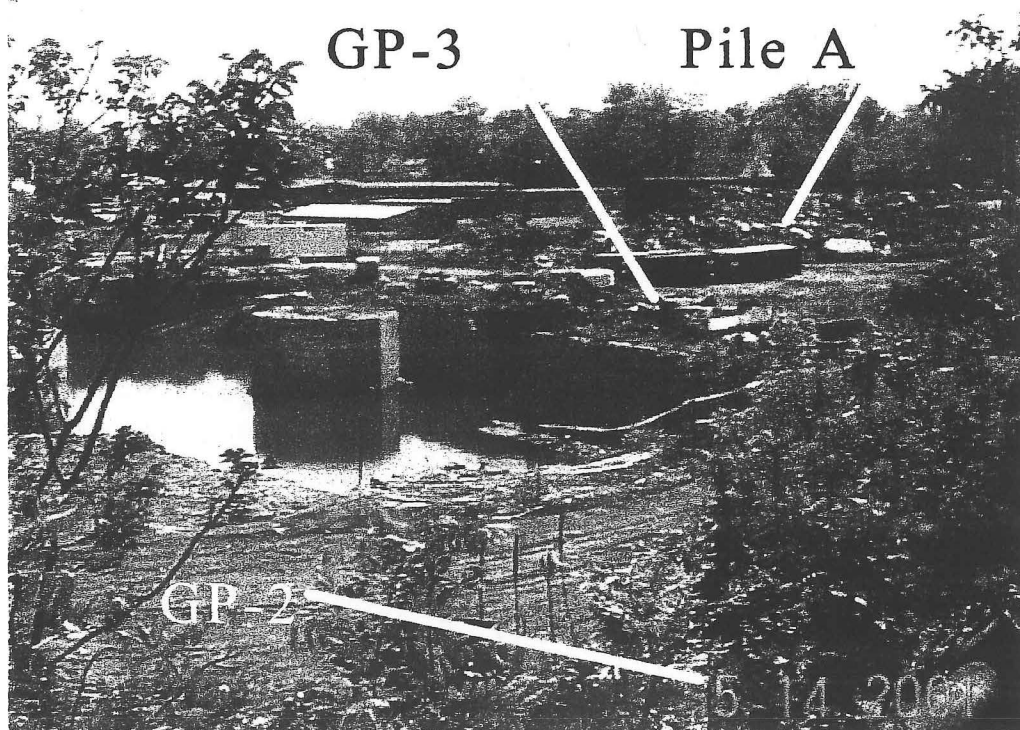
BELOW PHOTO: Mahoningside site, May 14, 2001 Recon with July 24-26, 2001 Sampling Locations
View from West Side of the River, from Railroad; Looking SouthWest at Site

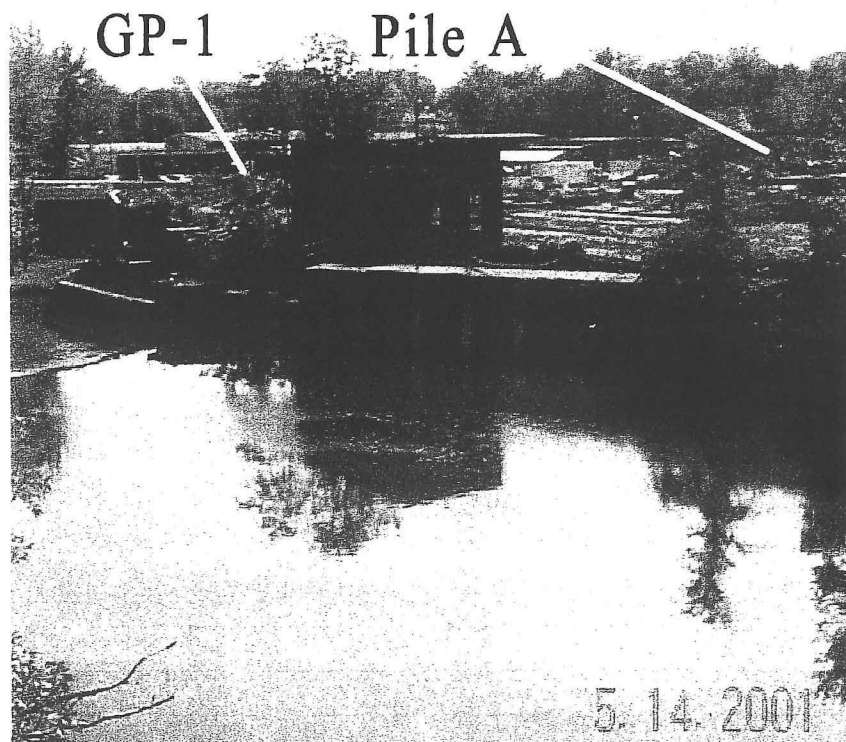
BELOW PHOTO: Mahoningside site, May 14, 2001 Recon with July 24-26, 2001 Sampling Locations
View from East Side of the River, from Railroad Bridge; Looking South West

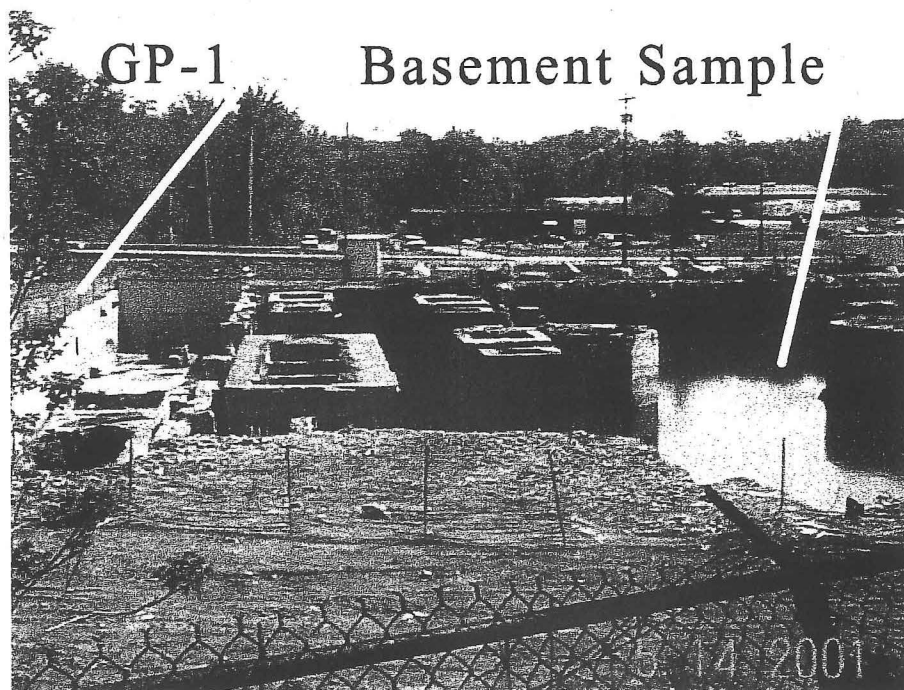
ABOVE PHOTO: Mahoningside site, May 14, 2001 Recon with July 24-26, 2001 Sampling Locations
View from East Side of the River, Looking West

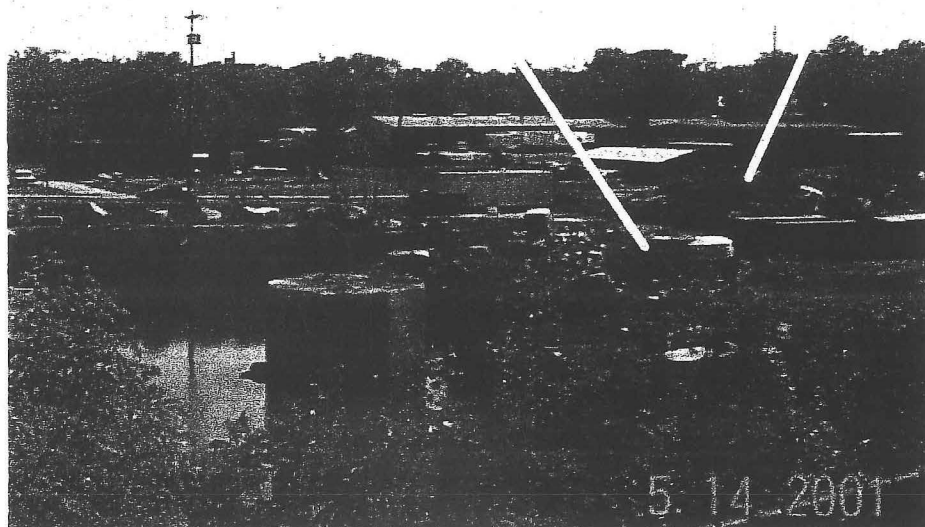
BELOW PHOTO: Mahoningside site, May 14, 2001 Recon with July 24-26, 2001 Sampling Locations
View from East Side of the River, from Railroad Bridge; Looking South West

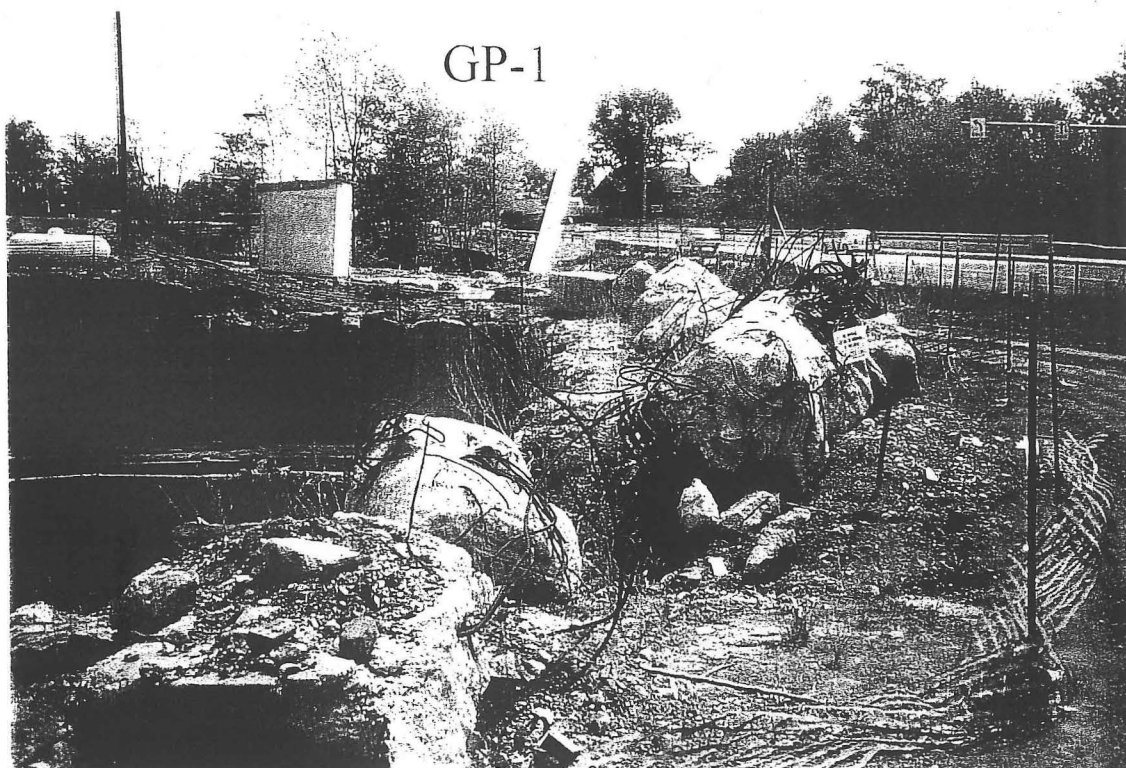
ABOVE PHOTO: Mahoningside site, May 14, 2001 Recon with July 24-26, 2001 Sampling Locations;
View from South West corner of the Basement Foundation; Looking East;
Summit Street in top right hand corner of photo

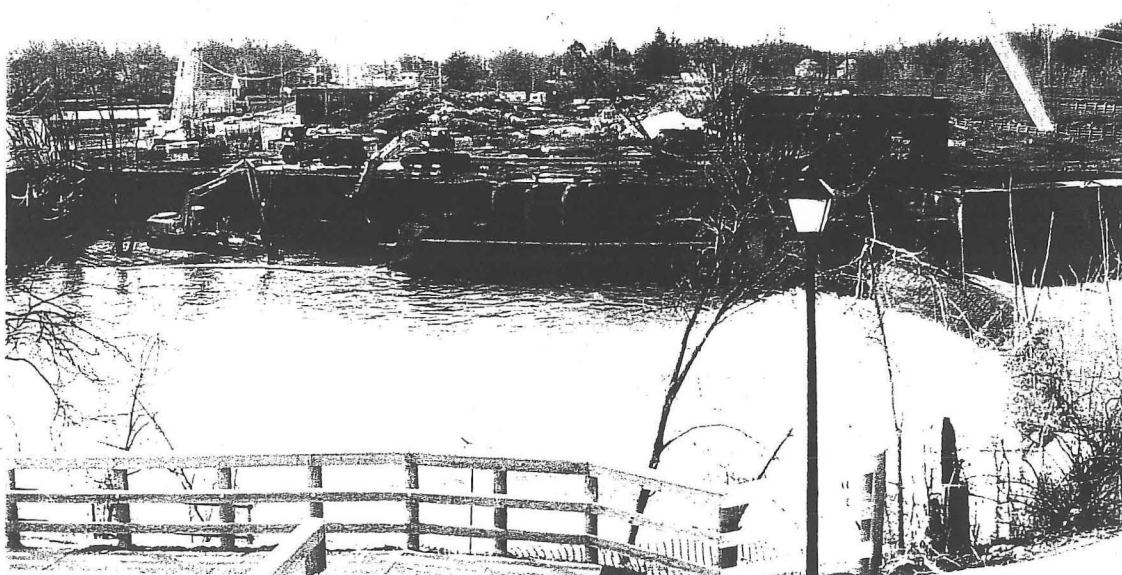
BELOW PHOTO: Mahoningside site, February 13, 2001 Recon with July 24-26, 2001 Sampling Locations
View from East Side of the River, Looking West from City Park area across Mahoning River;
USEPA Emergency Response operations going on to dredge PCB-contaminated sediment
from the river.

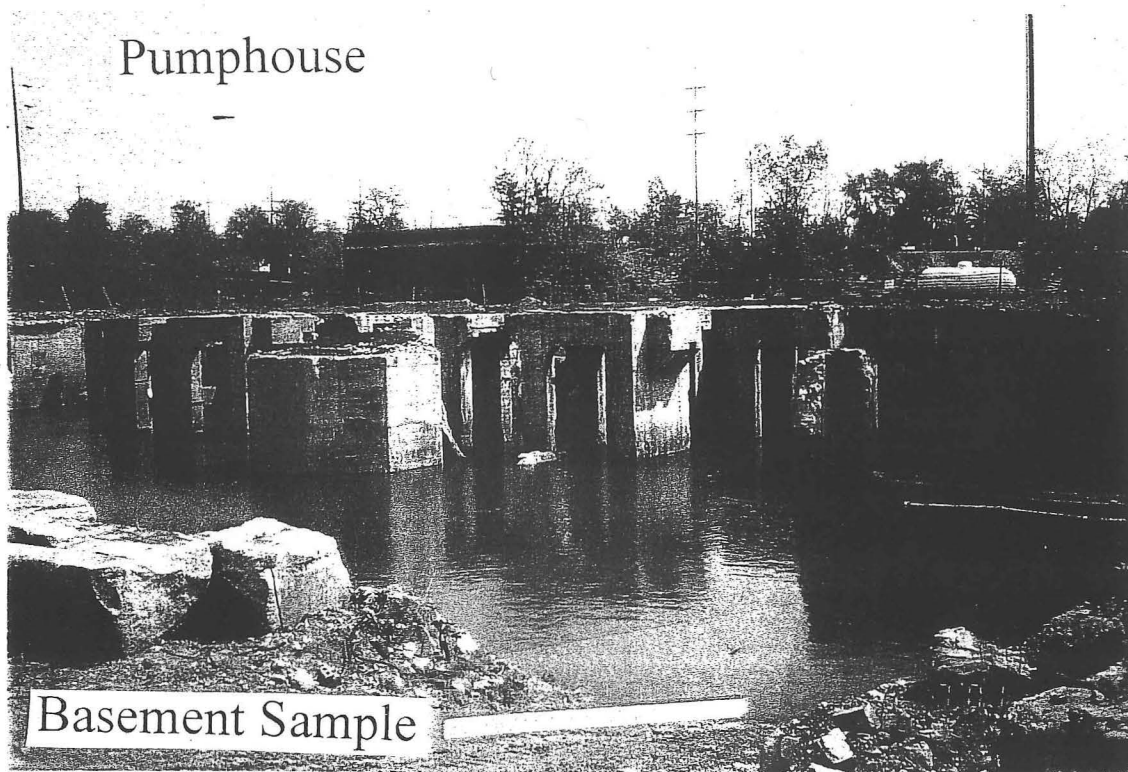
ABOVE PHOTO: Mahoningside site, May 14, 2001 Recon with July 24-26, 2001 Sampling Locations; View from South West corner of the Basement Foundation; Looking North East

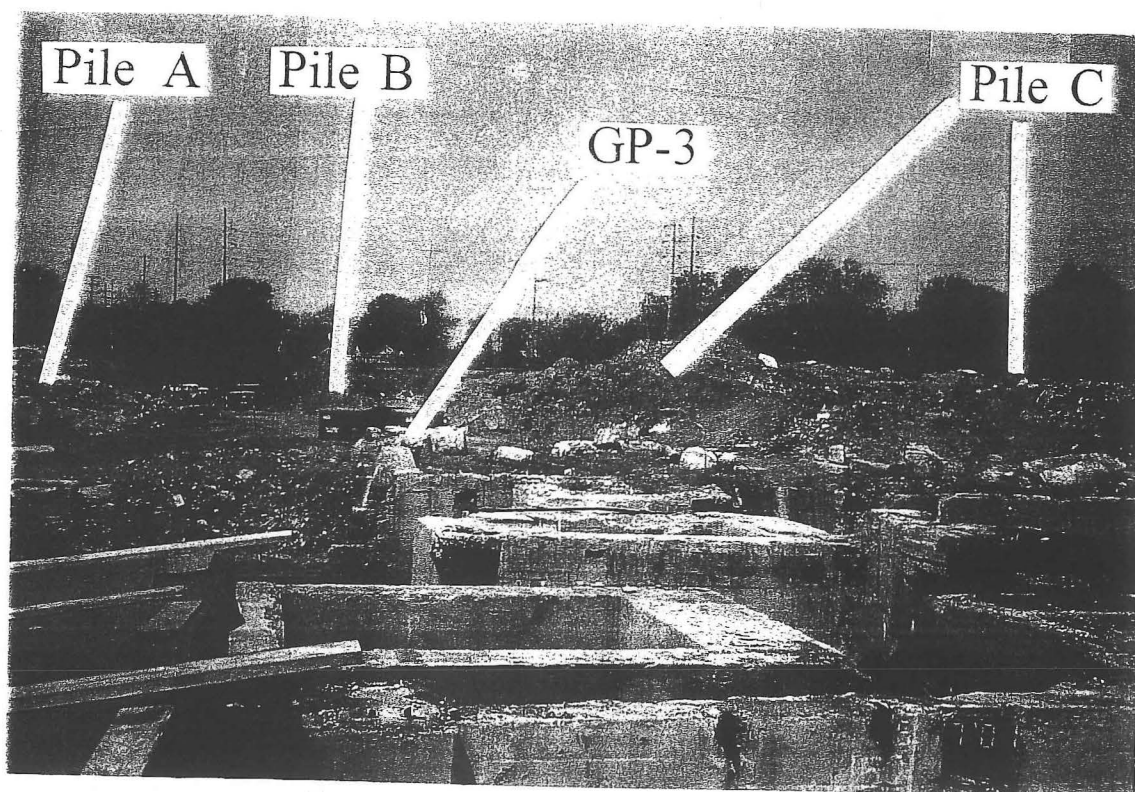
BELOW PHOTO: Mahoningside site, May 7, 2001 Recon with July 24-26, 2001 Sampling Locations; View from East Side of the Basement Foundation; Looking East
